# Effect of aluminum alloys' surface roughness on galvanic layers adhesion

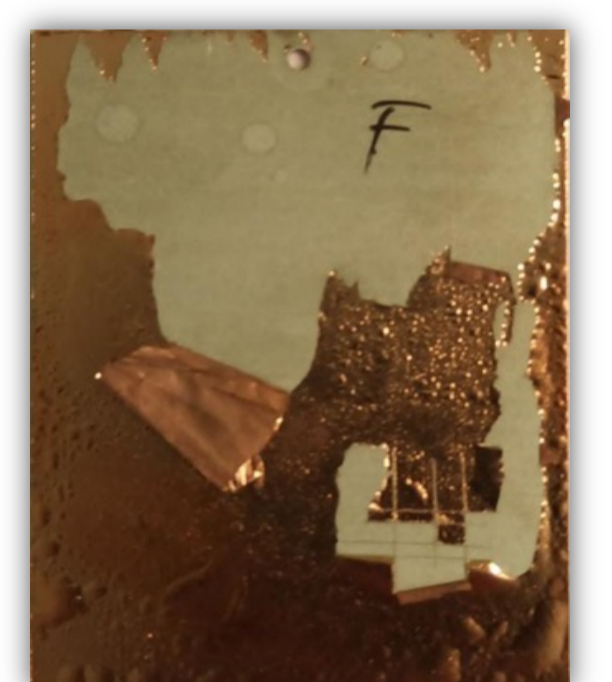
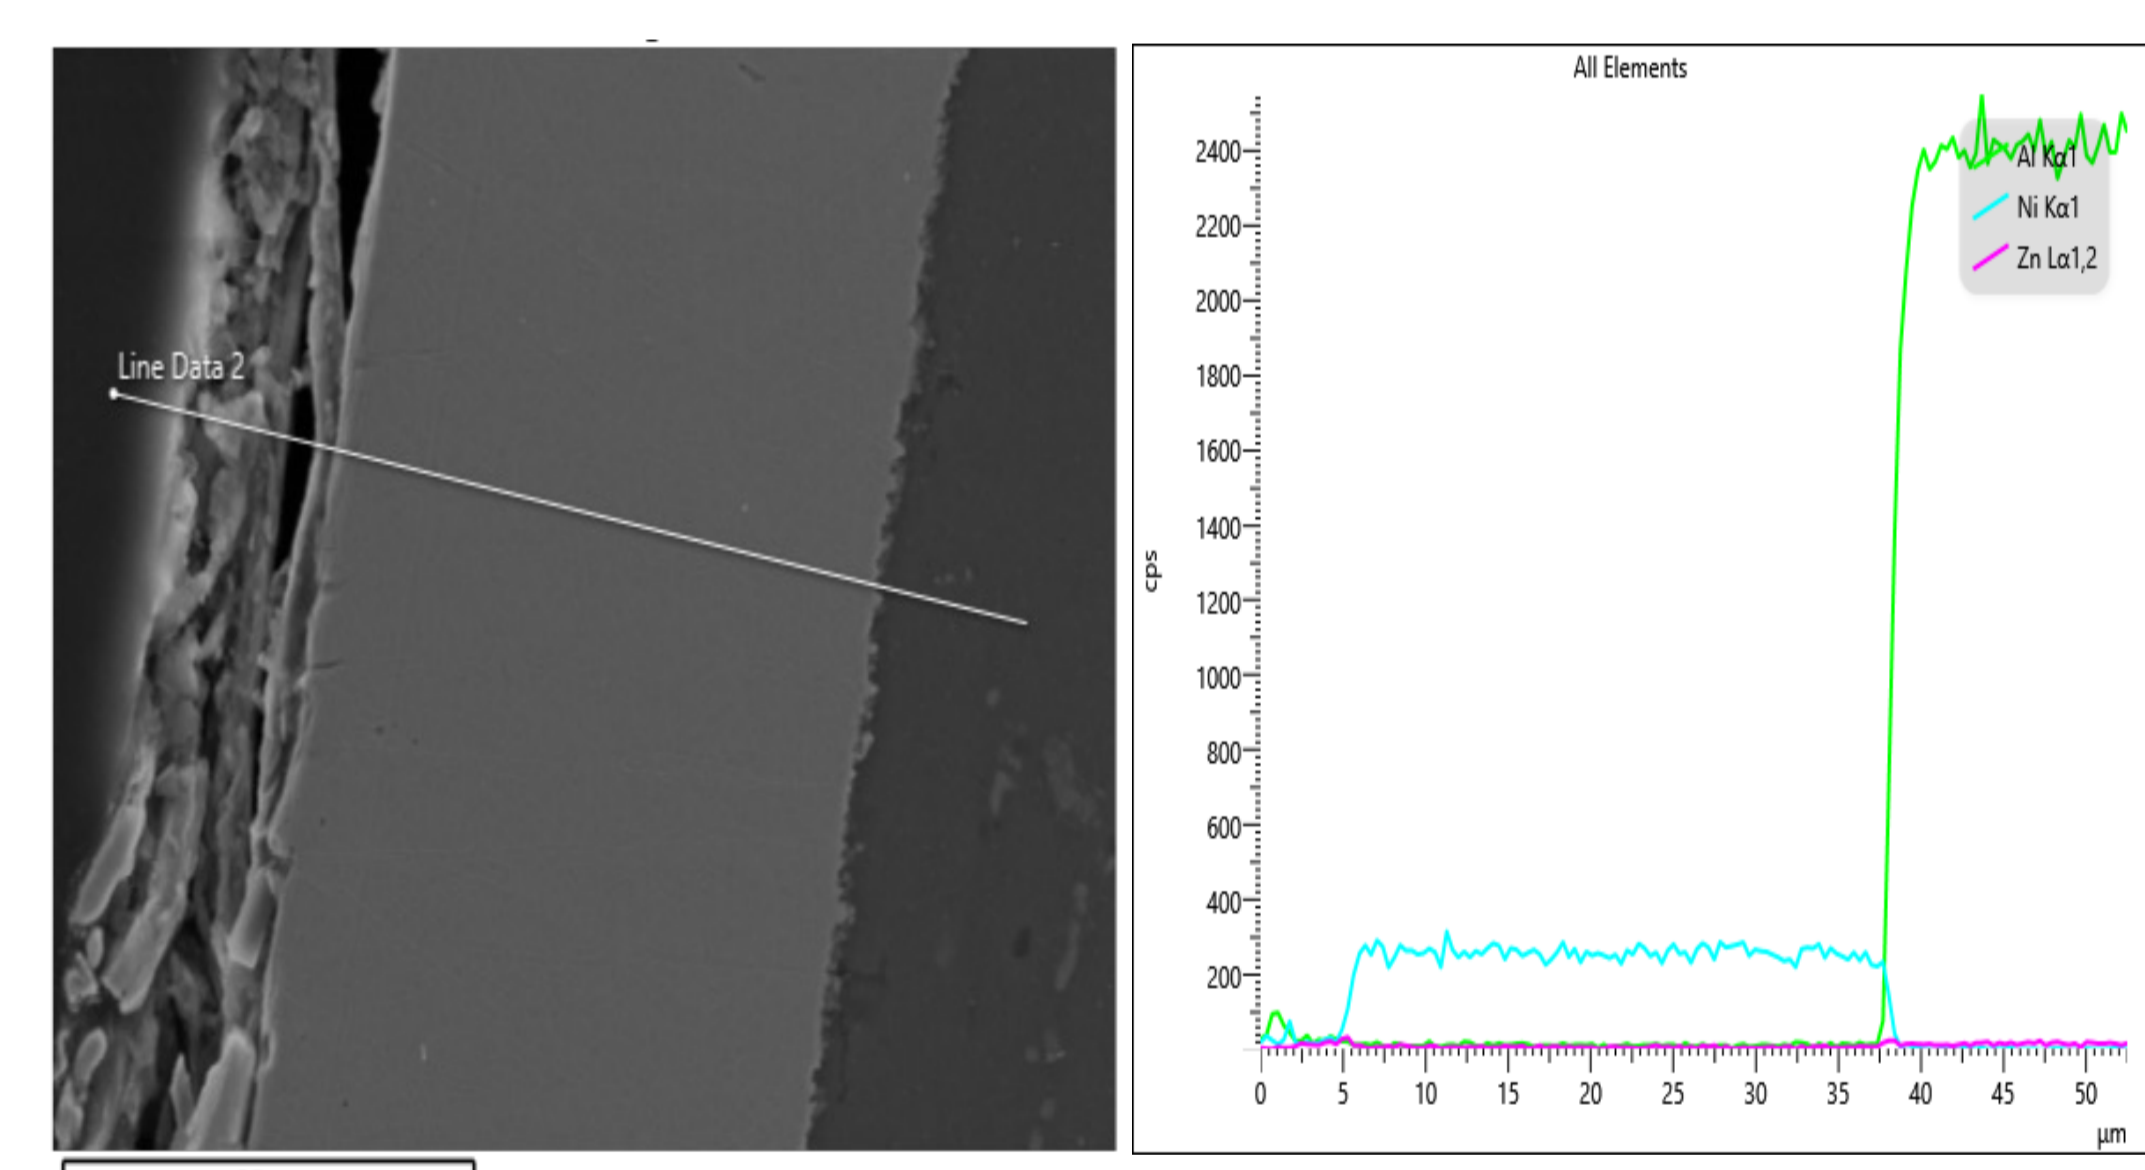
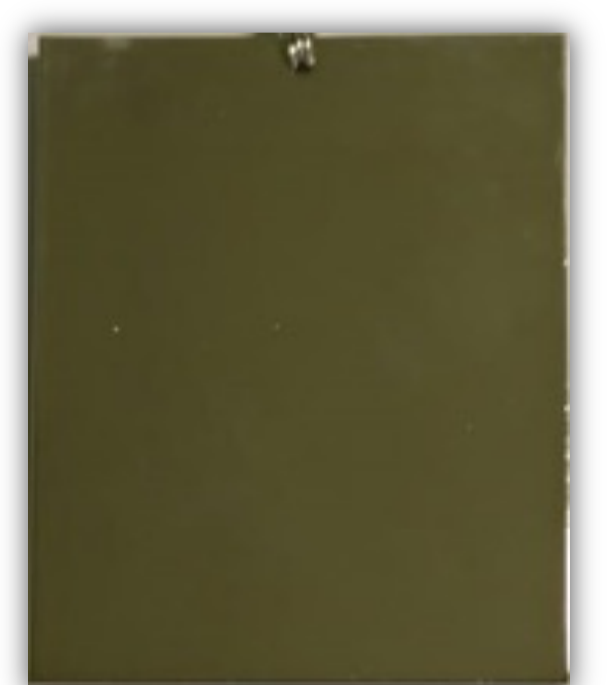
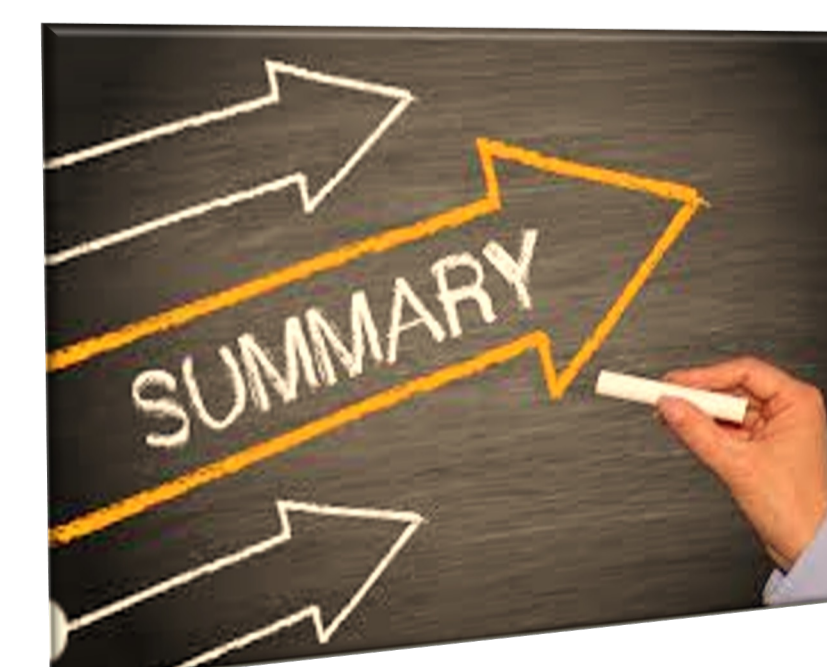
Both samples were chemically degreased and etched with proprietary solutions. Afterwards, a double zincate step was performed [5], followed by a deposition of a thick layer of nickel from a Watts nickel bath. Unpolished sample also underwent a copper plating step, with the purpose of further protecting the underlying structure. Samples were indeed eventually cut for SEM analysis. The sheltering effect was obtained for the polished sample by just prolonging the nickel deposition. Scanning Electron Microscope highlighted how a base material slightly rough surface allows to obtaining good adhesion when electroplating, differently from a highly rough surface. Indeed, by analyzing the unpolished plated sample, the EDS spectrum shows low signal overlapping between Al and Ni X-ray emission, which means poor adhesion between layers (Zn layer is too thin to be observed). Moreover, by performing the tape-test after cross-cutting the sample, data is confirmed since detachment between galvanic layers occurred. By performing the same test on a mechanically polished aluminum sample after electroplating, emission spectrum shows a greater extension of overlapping and the tape test does not give rise to detachment between layers.

Two samples of Al6082 with different surface roughness were chemically treated, galvanized and analyzed. Highly rough surface sample turned out to show poor adhesion whereas polished sample showed the opposite, highlighting how the samples preparation has a tremendous impact when it comes down to electroplating aluminum. Experiments were repeated twice to further confirm data.
